The University of
Nottingham

**MECHANICAL BEHAVIOUR OF
STRESS ABSORBING MEMBRANE
INTERLAYERS**

*Thesis Submitted to the University of Nottingham for the Degree of
Doctor of Philosophy*

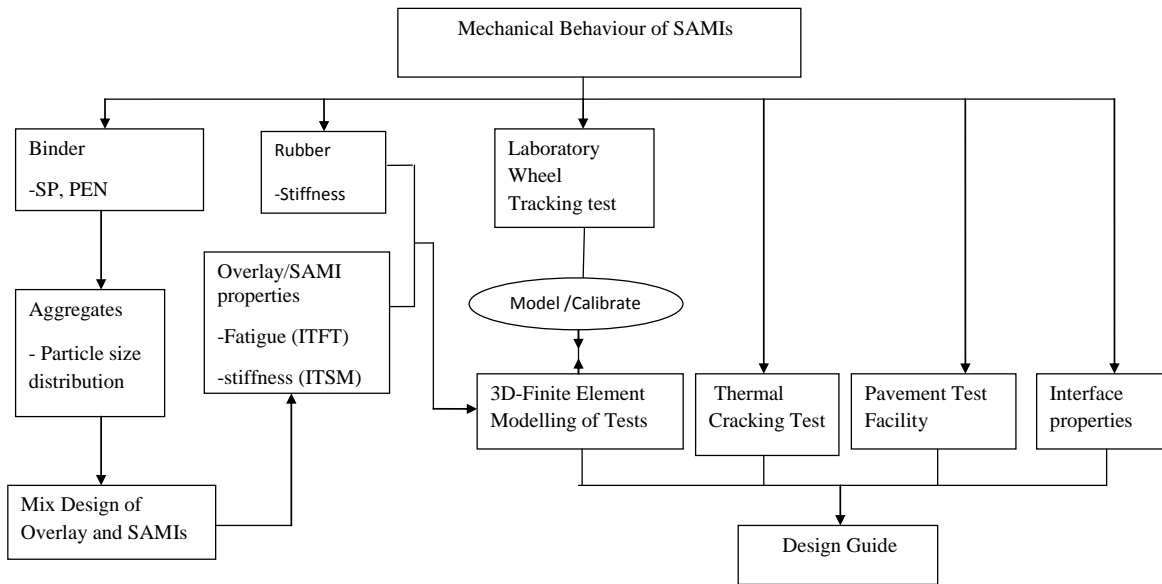
Figure 1.6: Proposed Research Plan

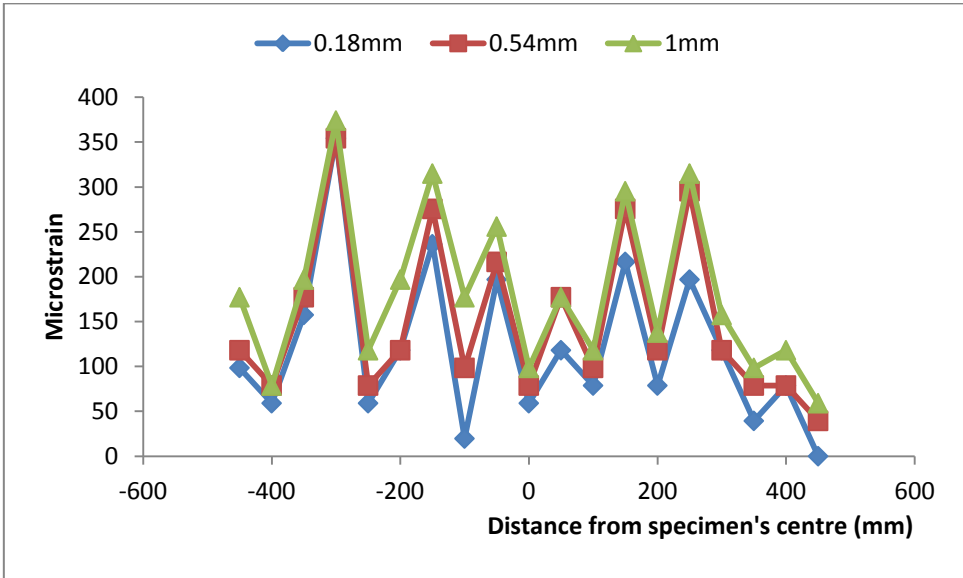
Figure 8.34: Surface strain distribution on specimen with proprietary SAMI D for 0.18mm, 0.54mm and maximum of 1mm crack openings
